TUNNEL INSPECTION REPORT

ST. ELIZABETHS HOSPITAL – WEST CAMPUS
WASHINGTON, D.C.

Report Prepared by:
Burgess & Niple, Inc.
4160 Pleasant Valley Road
Chantilly, VA 20151

Date: February 2006

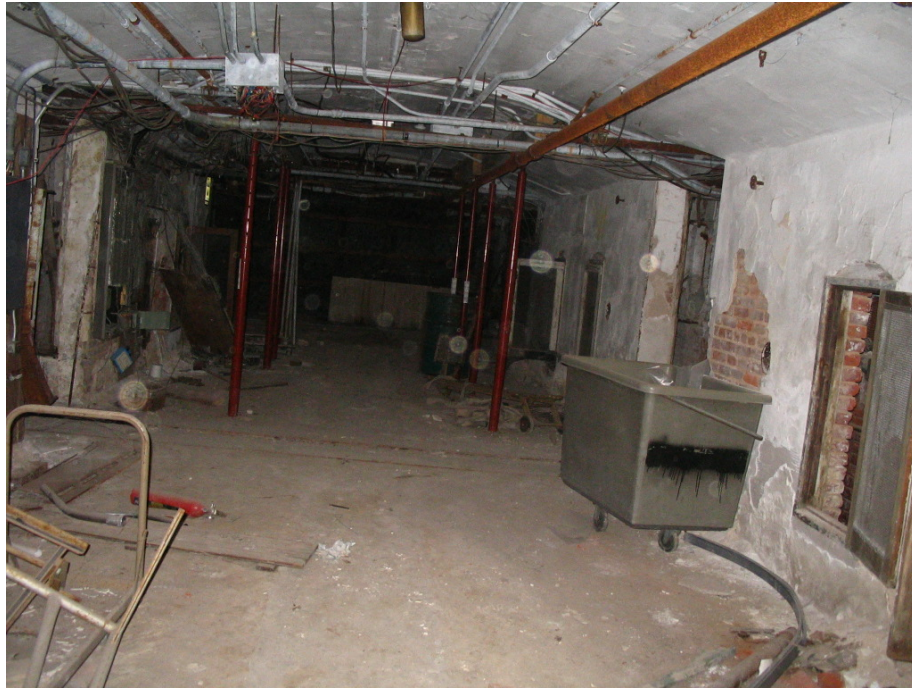
Photo 1: North portal

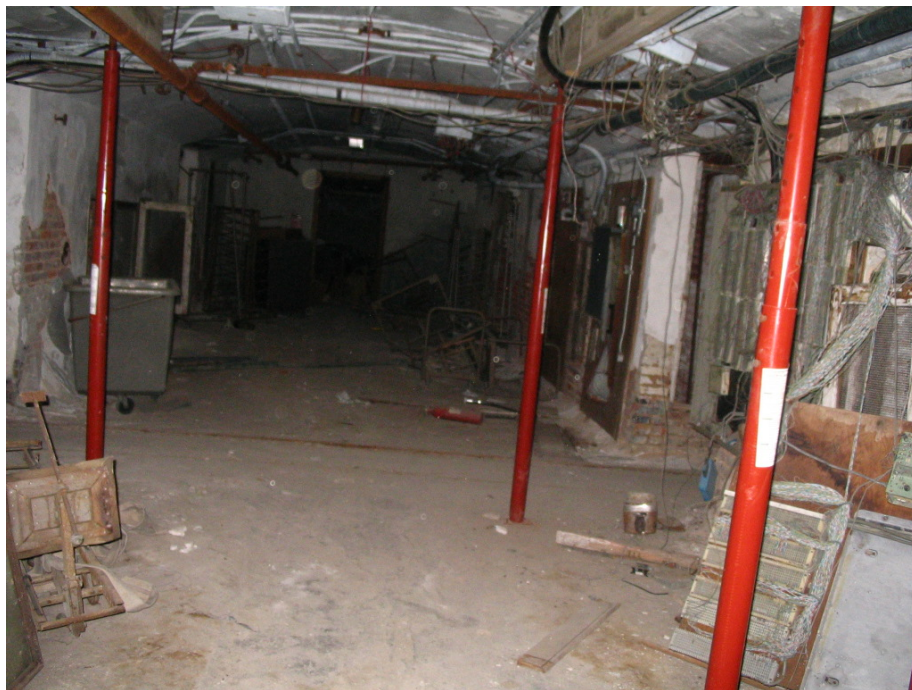
Photo 2: South portal

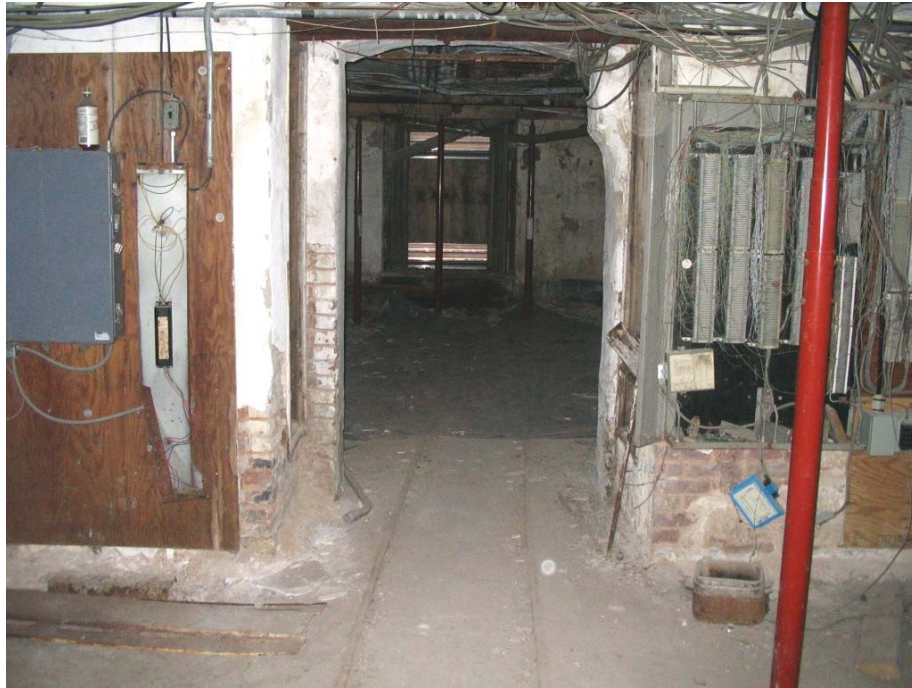
Photo 1: East portal

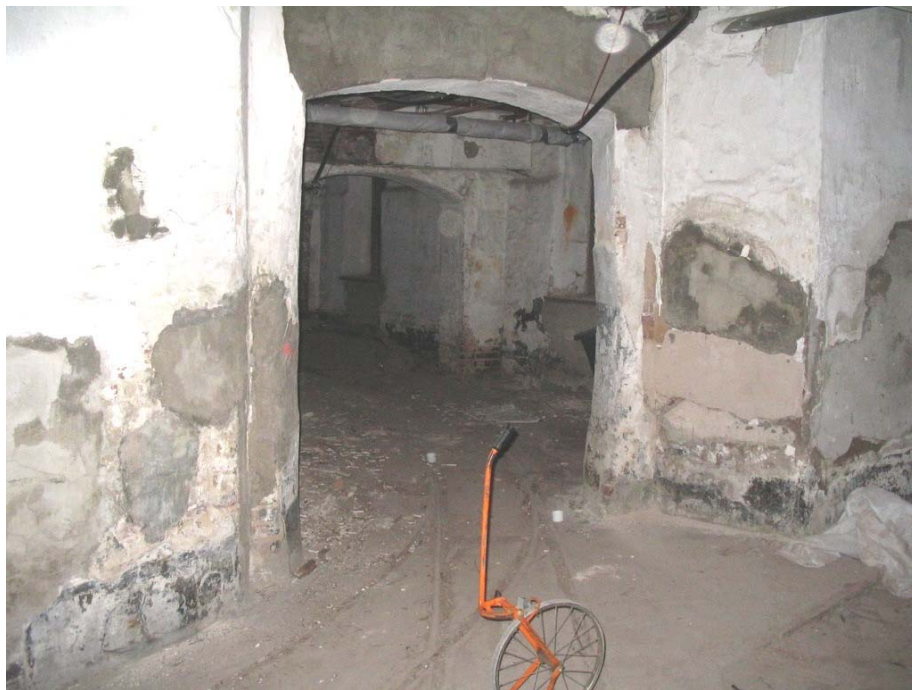
Photo 2: West portal

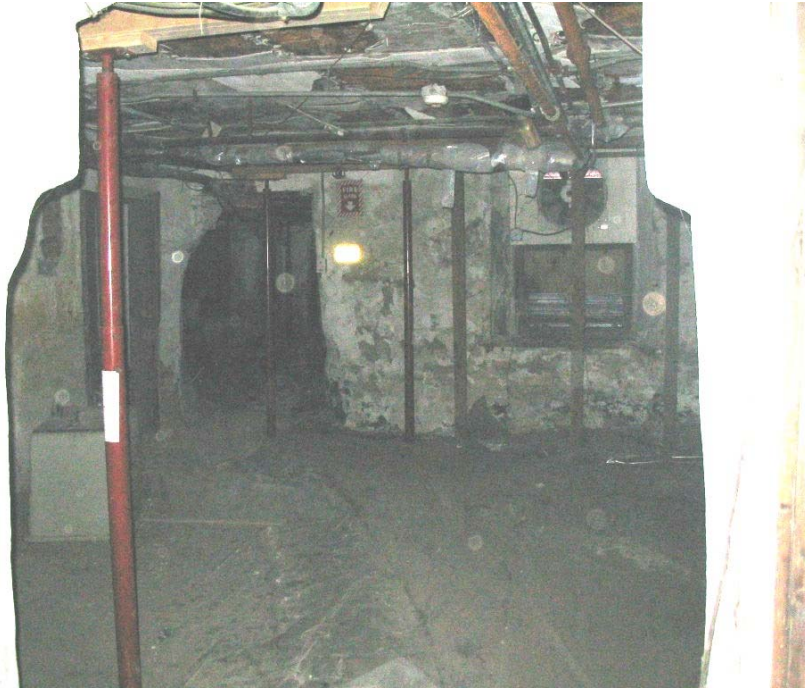
Photo 1: West portal

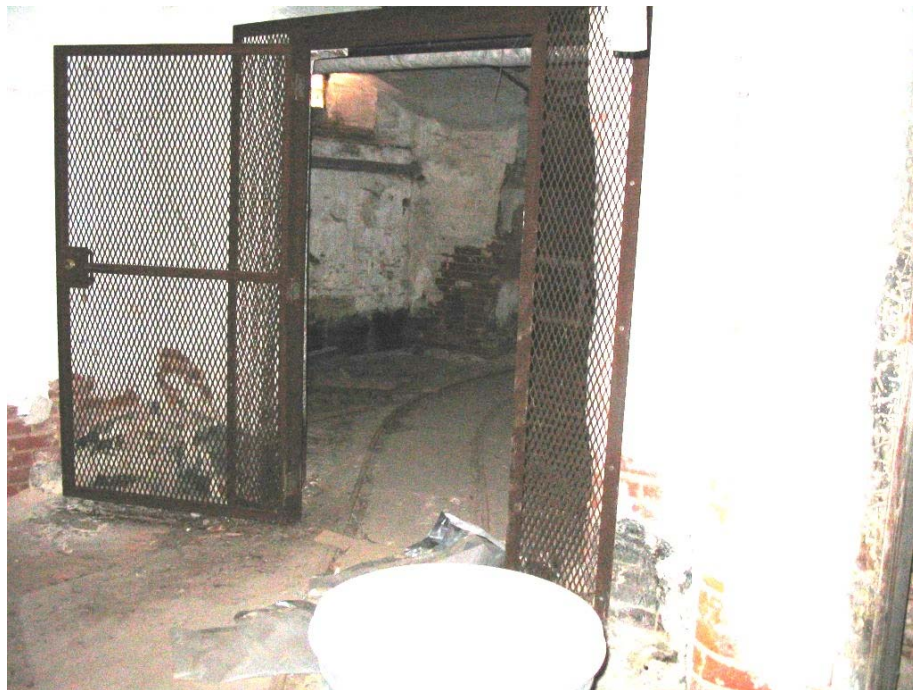
Photo 2: East portal

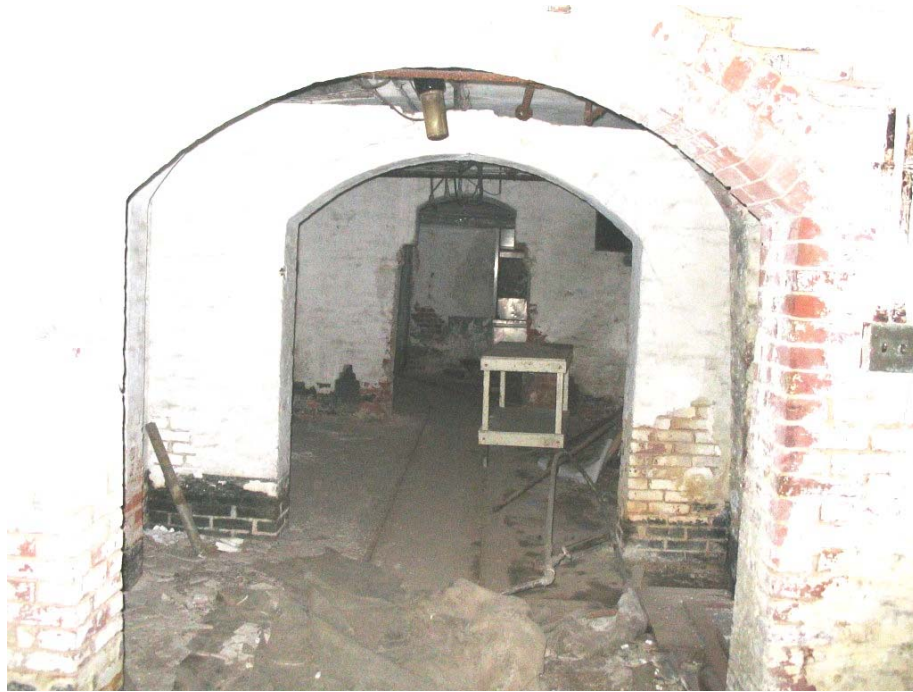
Photo 3: General view of lining

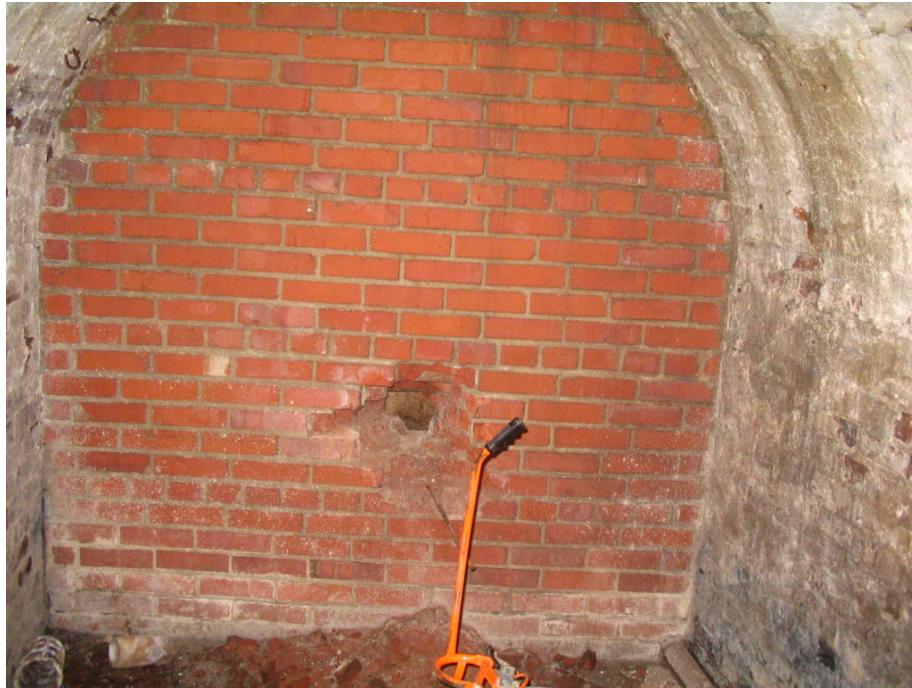
Photo 1: West portal, bricked off

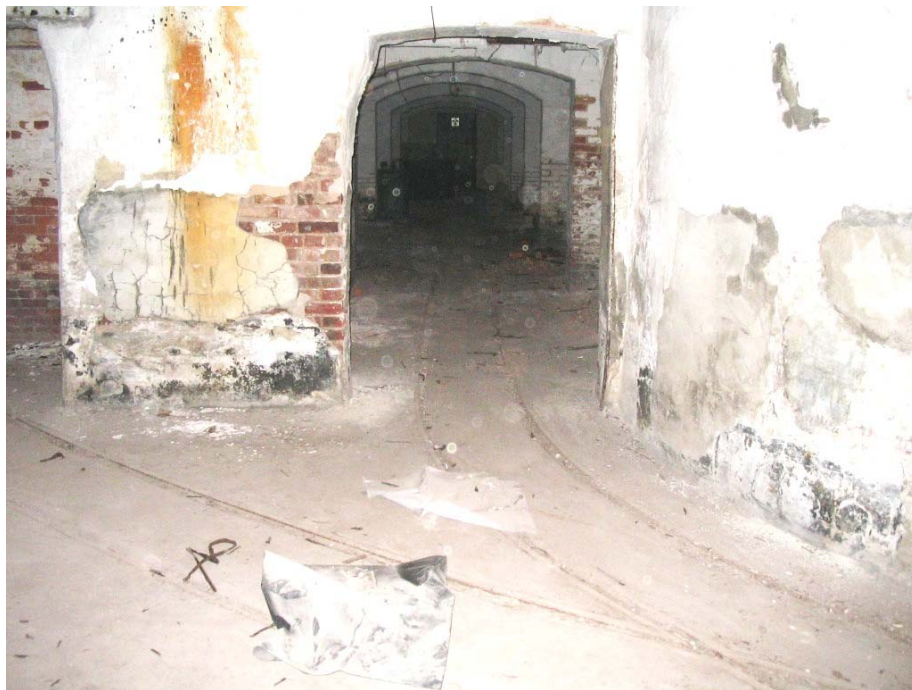
Photo 2: East portal

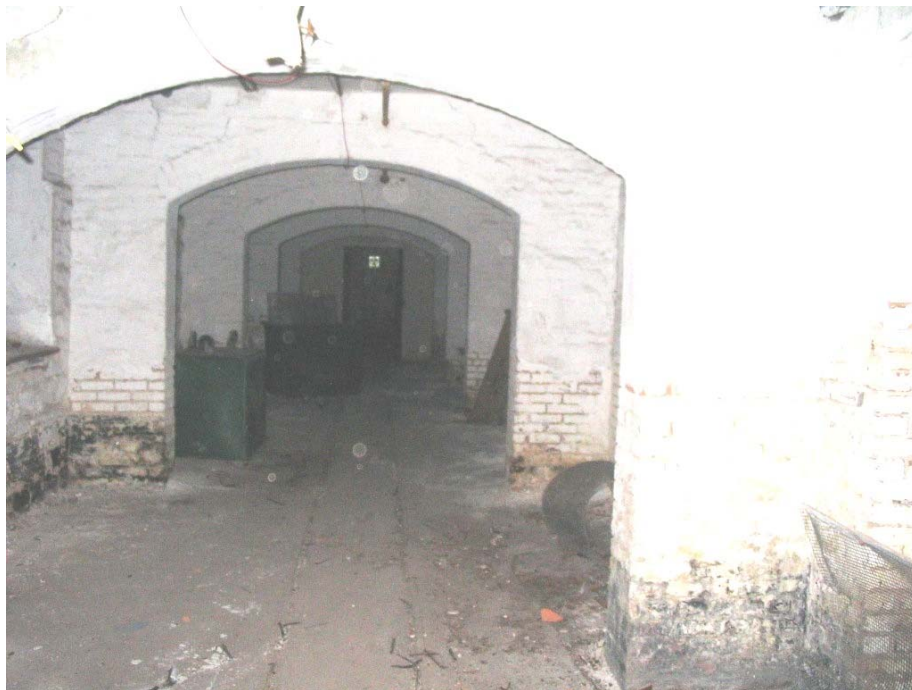
Photo 4: General view of tunnel, looking west from east portal

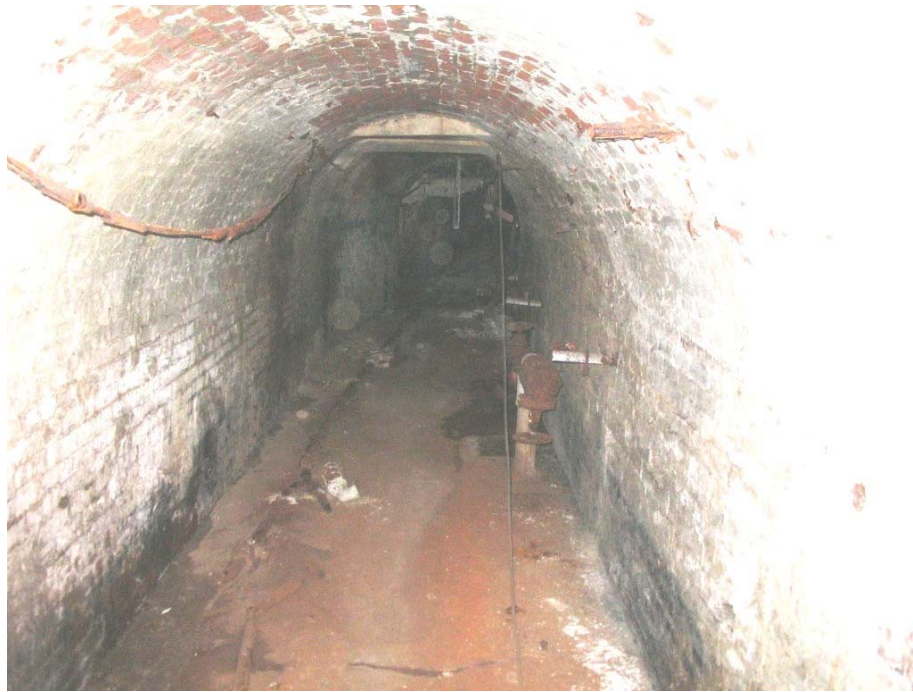
Photo 9: General view of lining, looking east from west portal

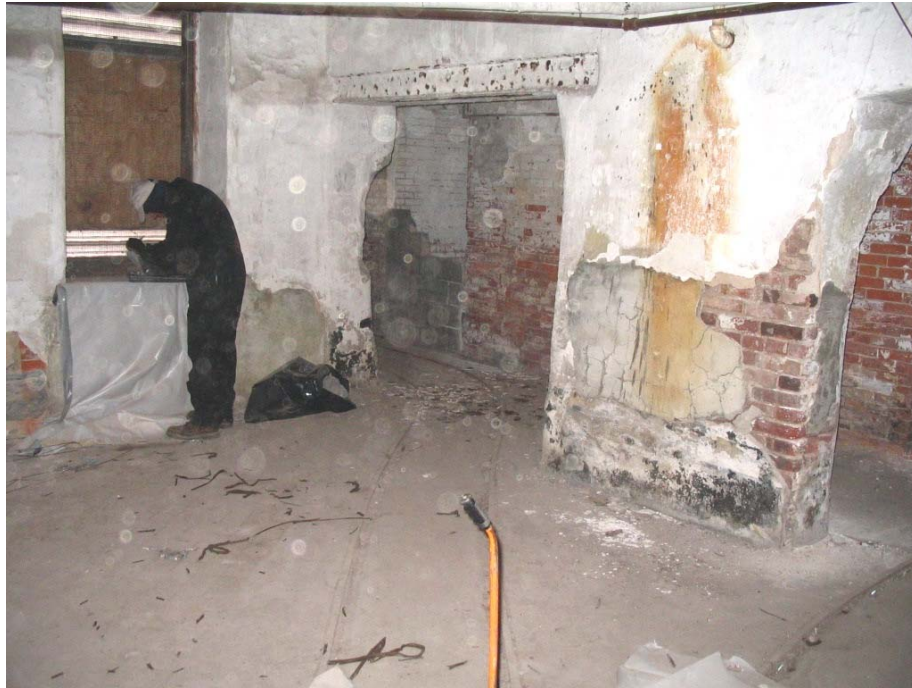
Photo 1: North portal

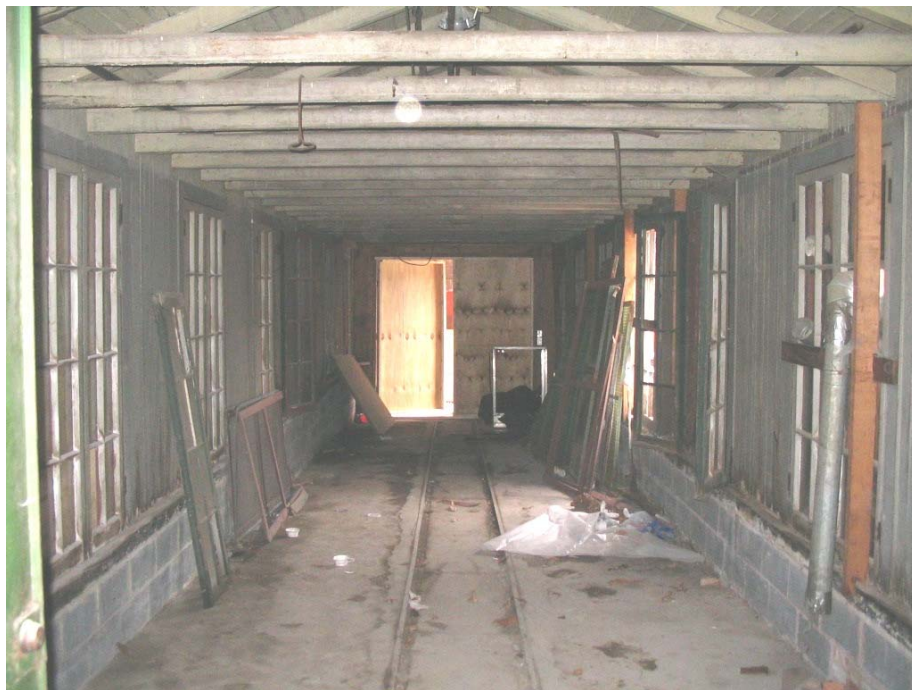
Photo 2: South portal

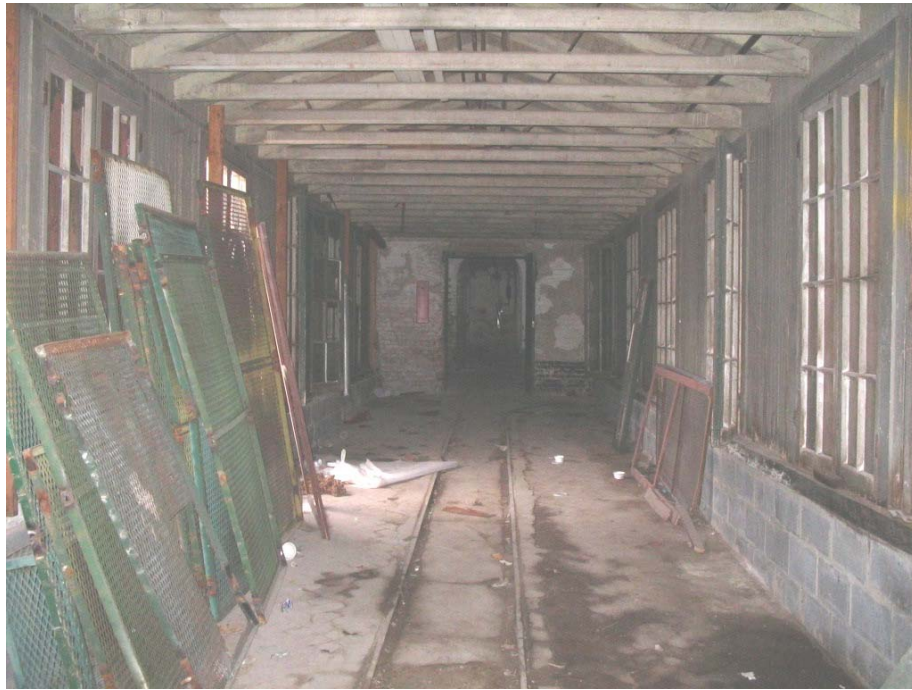
Photo 3: Looking north from south portal

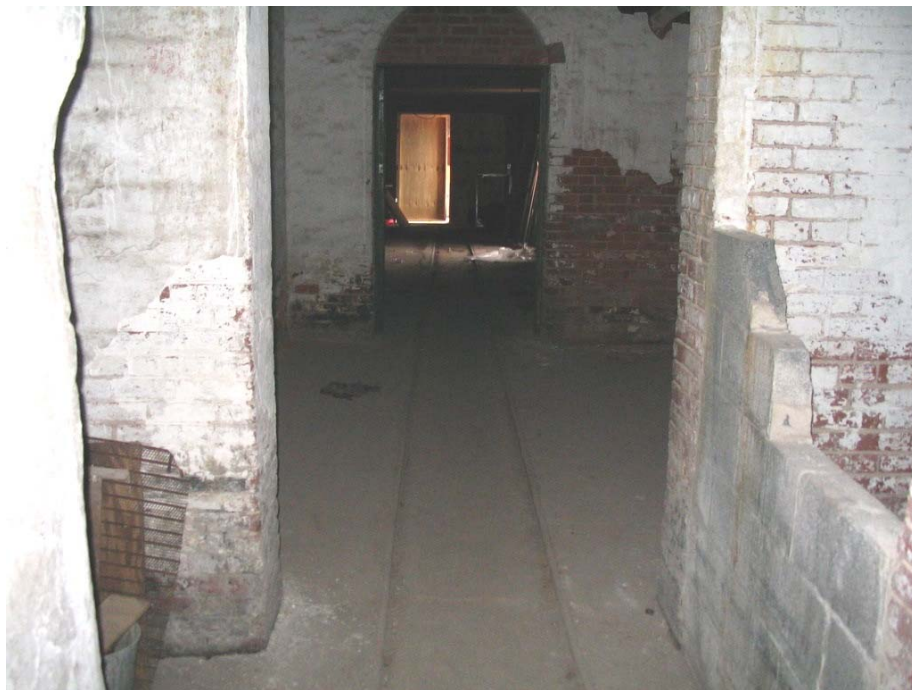
Photo 4: Looking south toward south portal

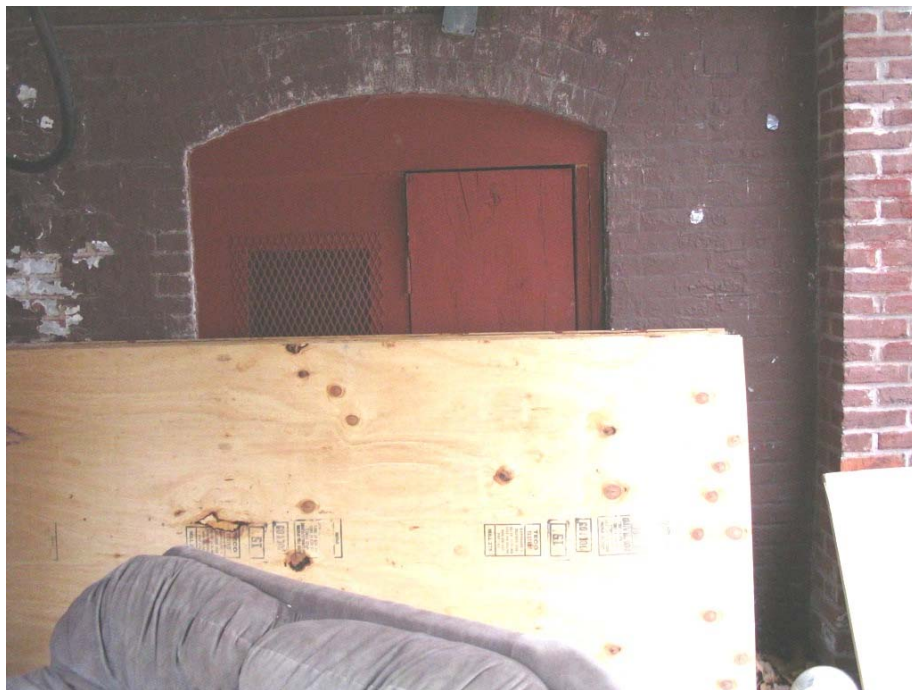
Tunnel previously connected the basement level of Building 3, West Wing to the basement level of Building 46, Bakery. Currently the passage way at Building 46 is blocked off preventing access to the Bakery.

Photo 6: Blocked access way to Building 46

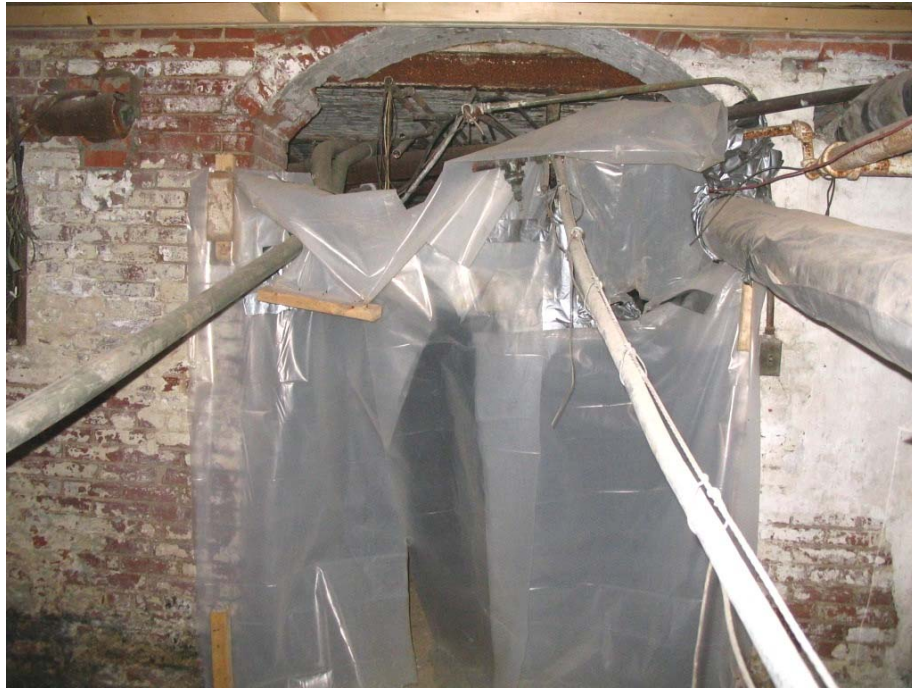
Photo 1: East portal

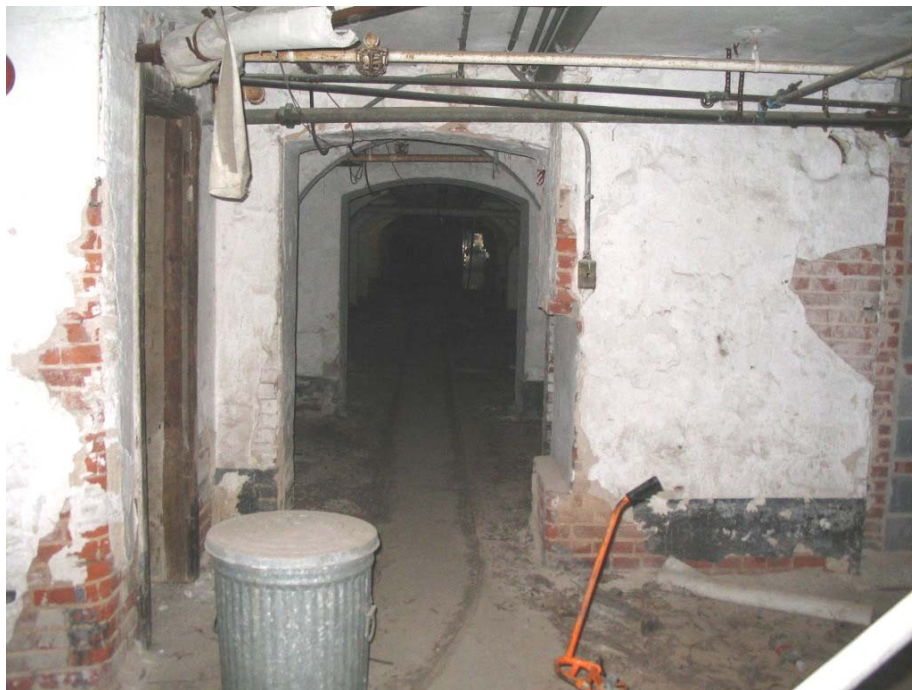
Photo 2: West portal

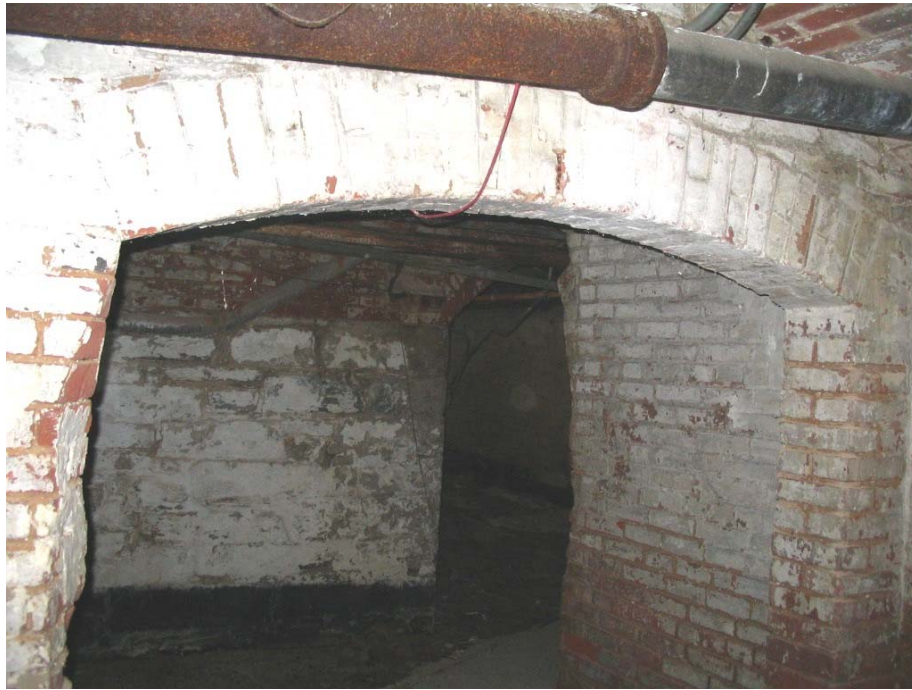
Photo 5: General view looking west

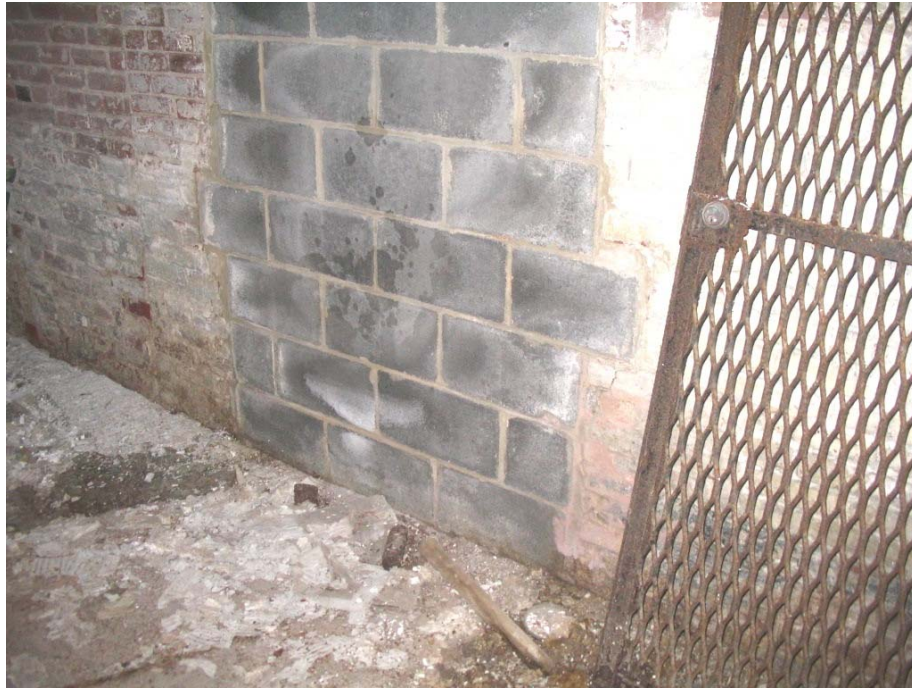
Photo 1: East portal; Note blocked off access way

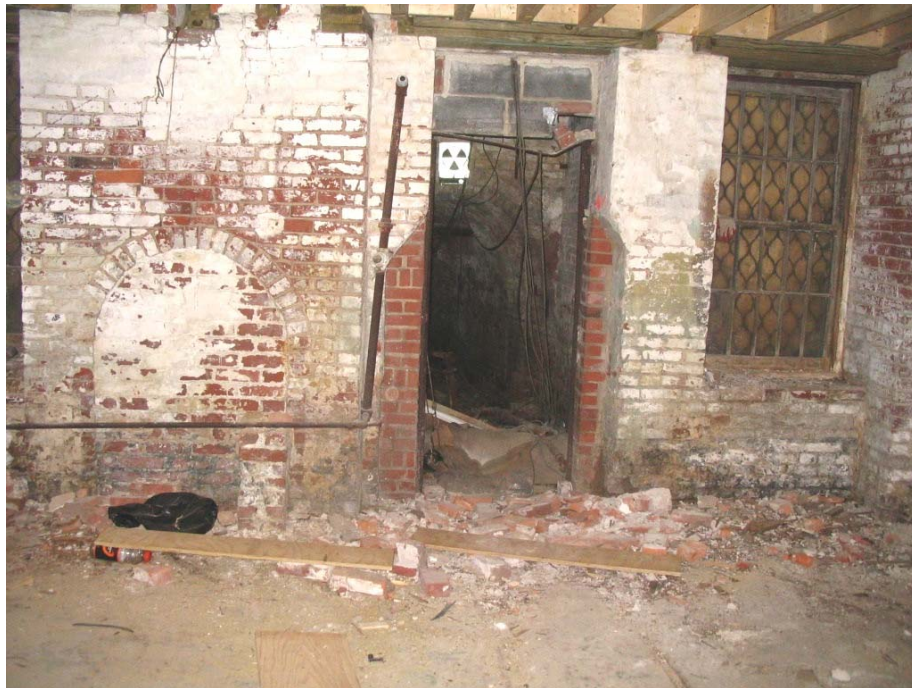
Photo 6: Looking south at access to Building 28

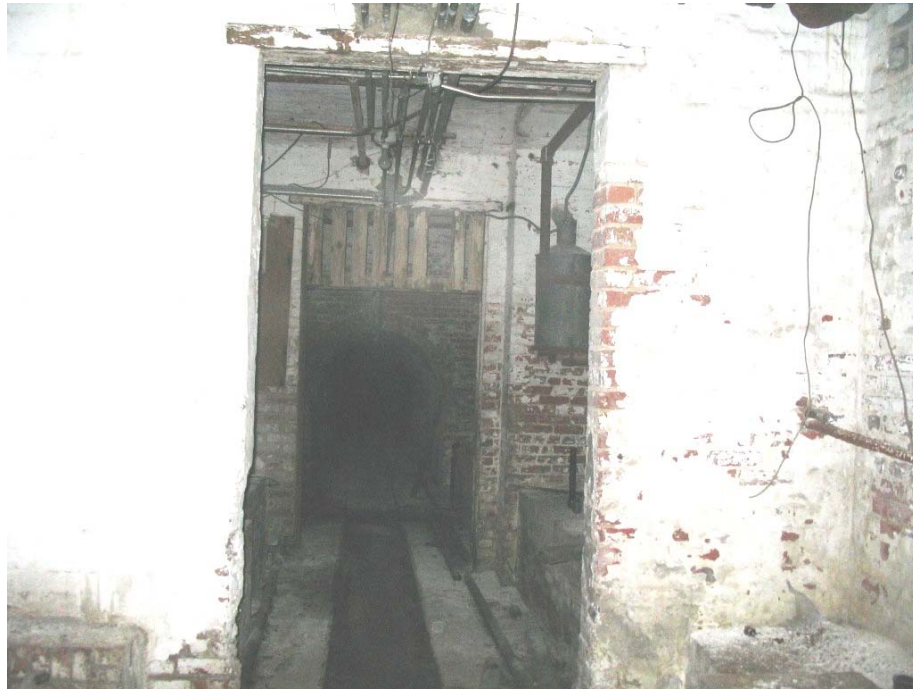
Photo 3: Looking north at south portal from Building 28

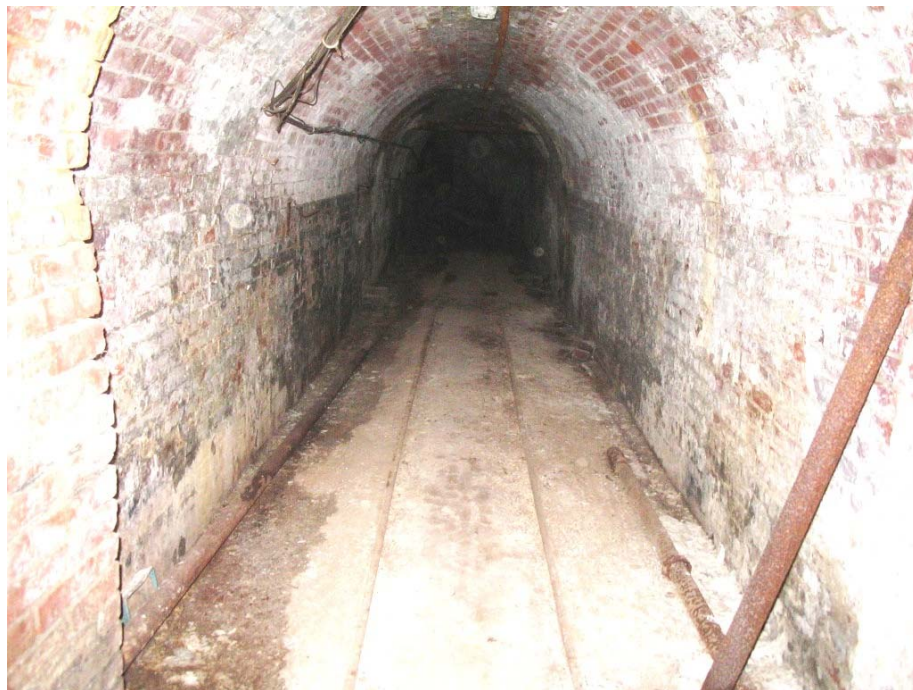
Photo 4: General view of lining, looking north from south portal
